**UNITED STATES ENVIRONMENTAL PROTECTION AGENCY
REGION 5
77 WEST JACKSON BOULEVARD
CHICAGO, IL 60604**

SUBJECT: INSPECTION REPORT – Savoy Energy, L.P., Adrian 25 facility, Adrian, MI

Date of Inspection: April 28, 2014

Purpose of Inspection: The purpose of conducting an inspection of Savoy Energy, L.P.'s Adrian 25 facility was to respond to a citizen complaint of odor and related adverse health effects.

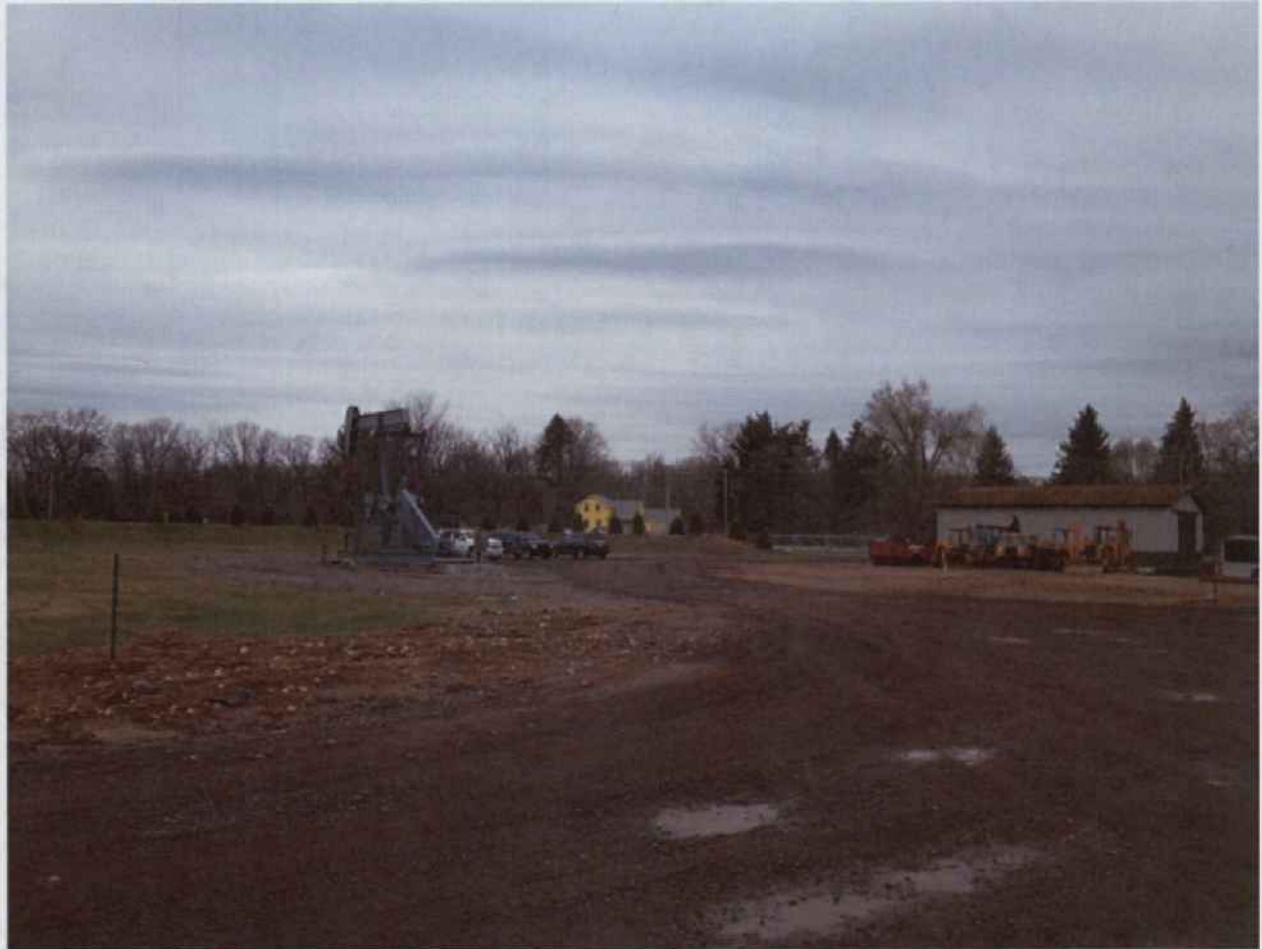
- 1) View approximately from the tank battery, looking WNW. Note the proximity of the house and public highway to the facility.

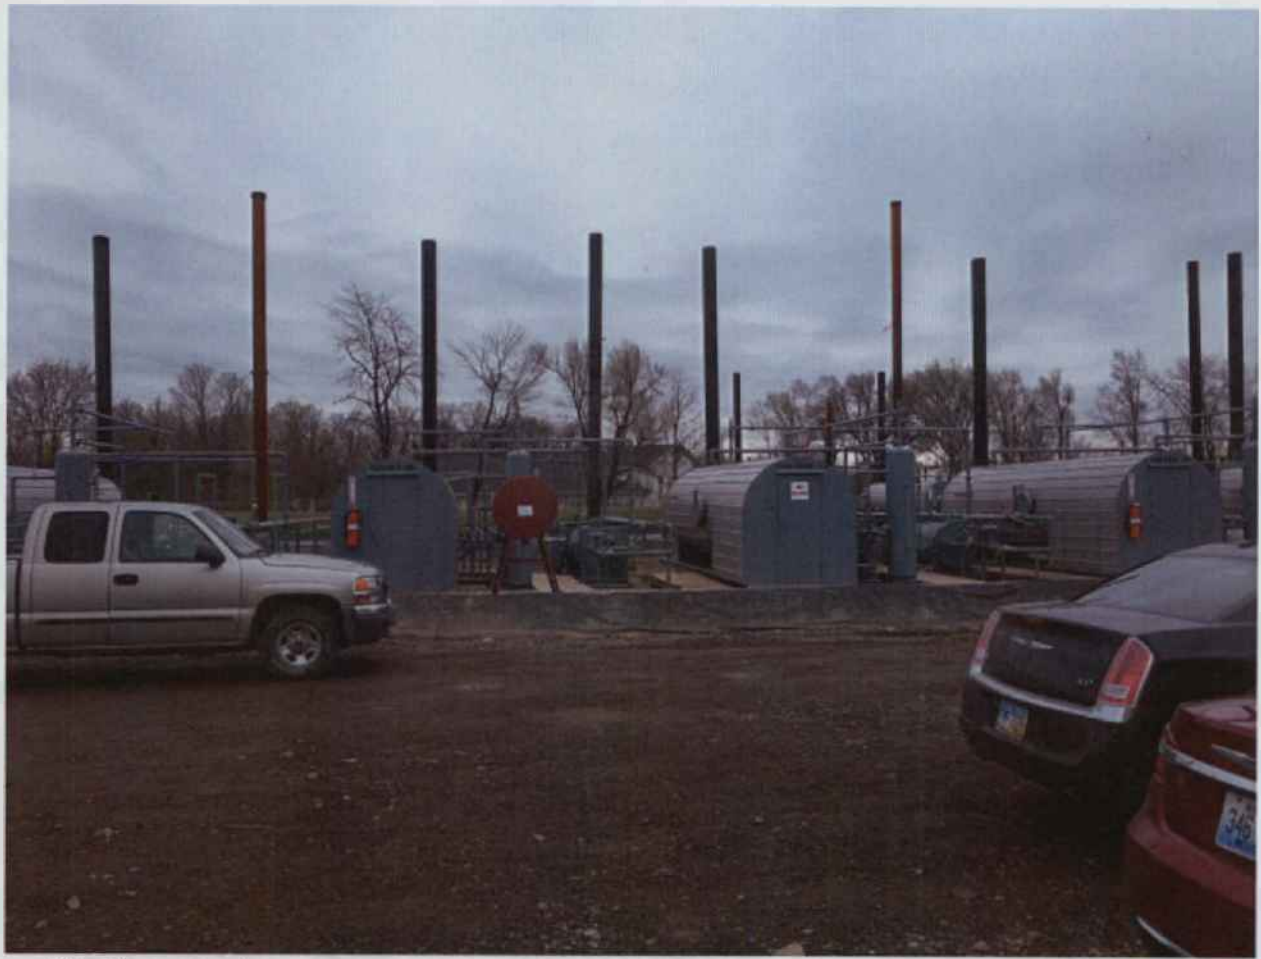
The Adrian 25 facility processes oil, water, and natural gas that is piped to the facility from seven nearby wells. The oil/water/gas emulsion arrives at the facility from each well and travels through a line heater, which uses methanol as an antifreeze. The oil/water/gas then goes to a "heater treater" which separates the emulsion into individual components. The heater treaters each have a gas-fired burner as the source of heat. There are seven line heaters and seven heater

treaters, one for each well (photo 2). Each well is metered individually to ensure that per-well production limits are complied with and also to ensure that the property owner where the well is located is properly compensated.

2) Heater treaters

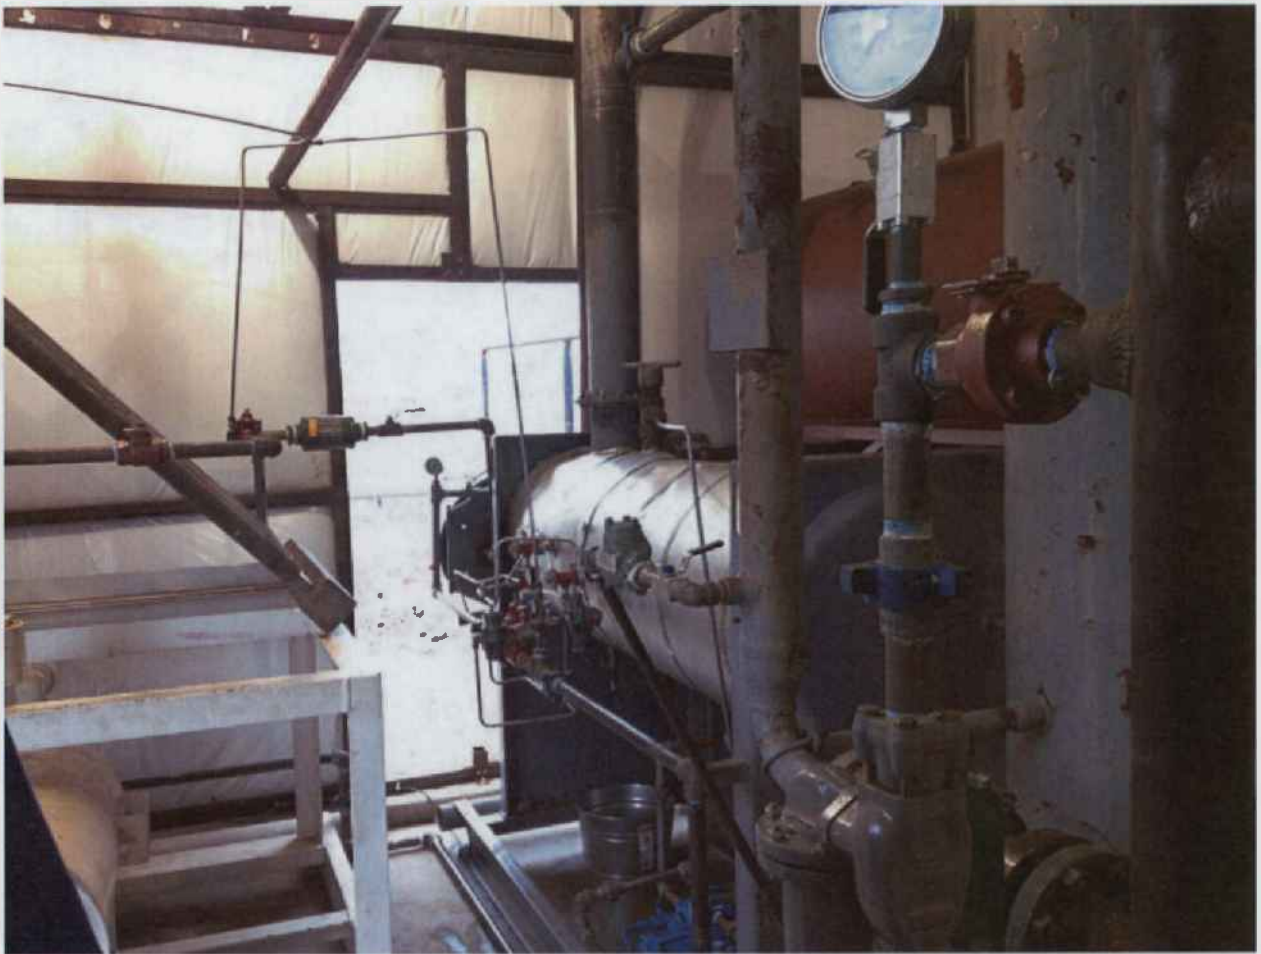
The compressed gas then goes to the glycol dehydrator where water is removed (photo 3). The dehydrator is equipped with a condenser to remove steam and VOCs (primarily "BTEX" – benzene, toluene, ethylbenzene, and xylene). The gas then is piped to the refrigeration plant (photo 7) where it is cooled to -40°F so the propane can be stripped out. Mr. Rokos did not know the type of refrigerant used but he stated that he assumed it was "Freon." The propane is then stored on-site in a 30,000 gallon tank (photo 11) until it is transported to sale via truck. The propane tank is pumped out approximately once per week to ten days. Methane and ethane are pulled off the propane tank and used as fuel gas for various pieces of equipment at the facility. From the refrigeration plant, the gas is piped to the sales line. The gas line is also connected to the flare – if there is a pluggage in the gas line, the gas will back up and vent to the flare. Prior to April 8, 2014, all gas was sent to the flare.

3) Glycol dehydrator (horizontal cylinder) with condenser (at left).

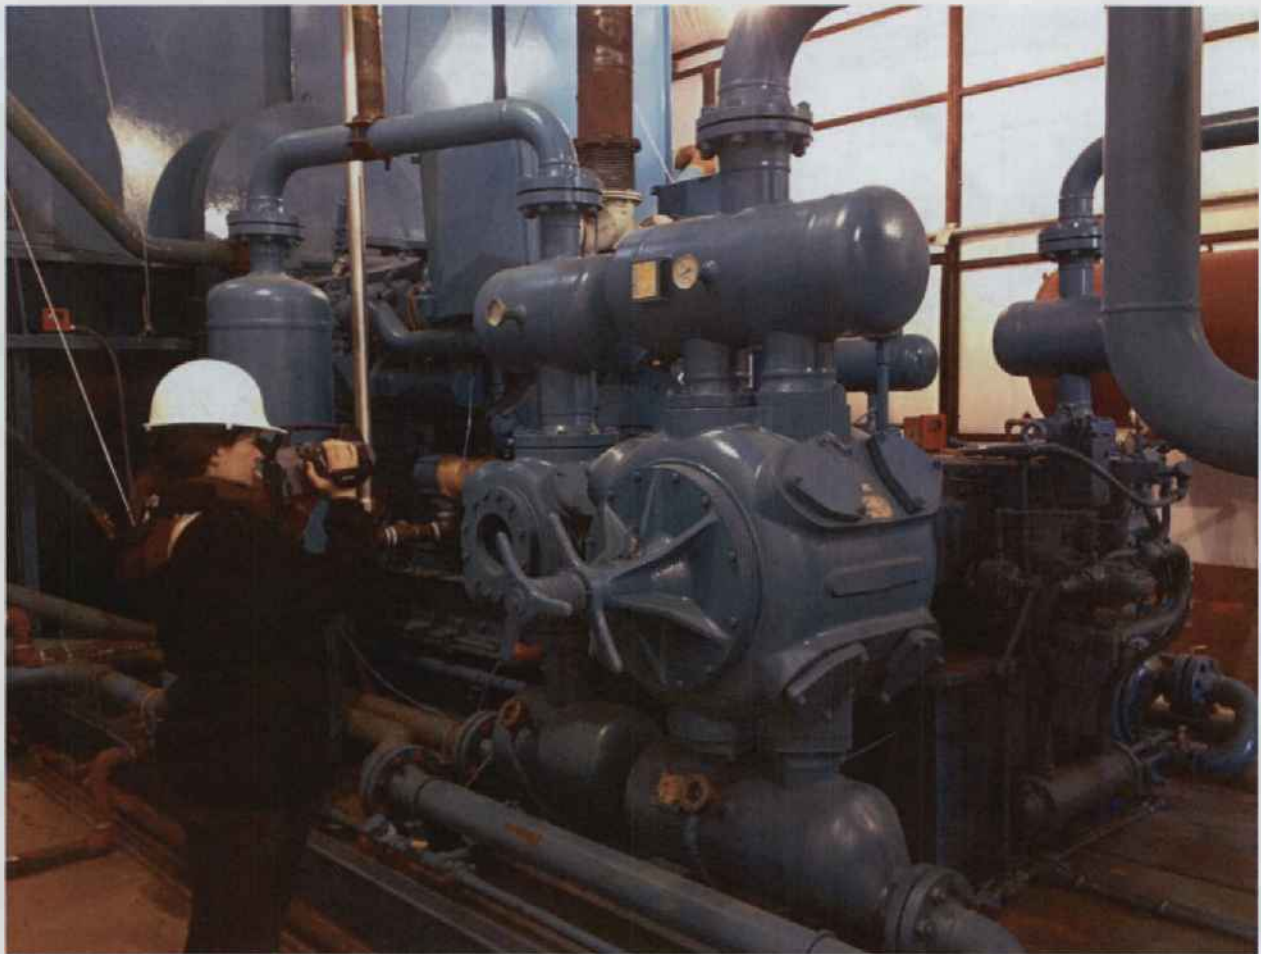
The gas travels to a 4-stage compressor which increases the pressure from about 20 psi to approximately 650 psi (photo 4). The compressor began operating on April 8, 2014 and is equipped with a catalytic converter as an air pollution control device. The crude gas/oil mixture does not contain any sulfur compounds, so no "sour gas" treatment is necessary.

4) EPA inspector Katy Bellairs viewing the compressor with the IR camera.

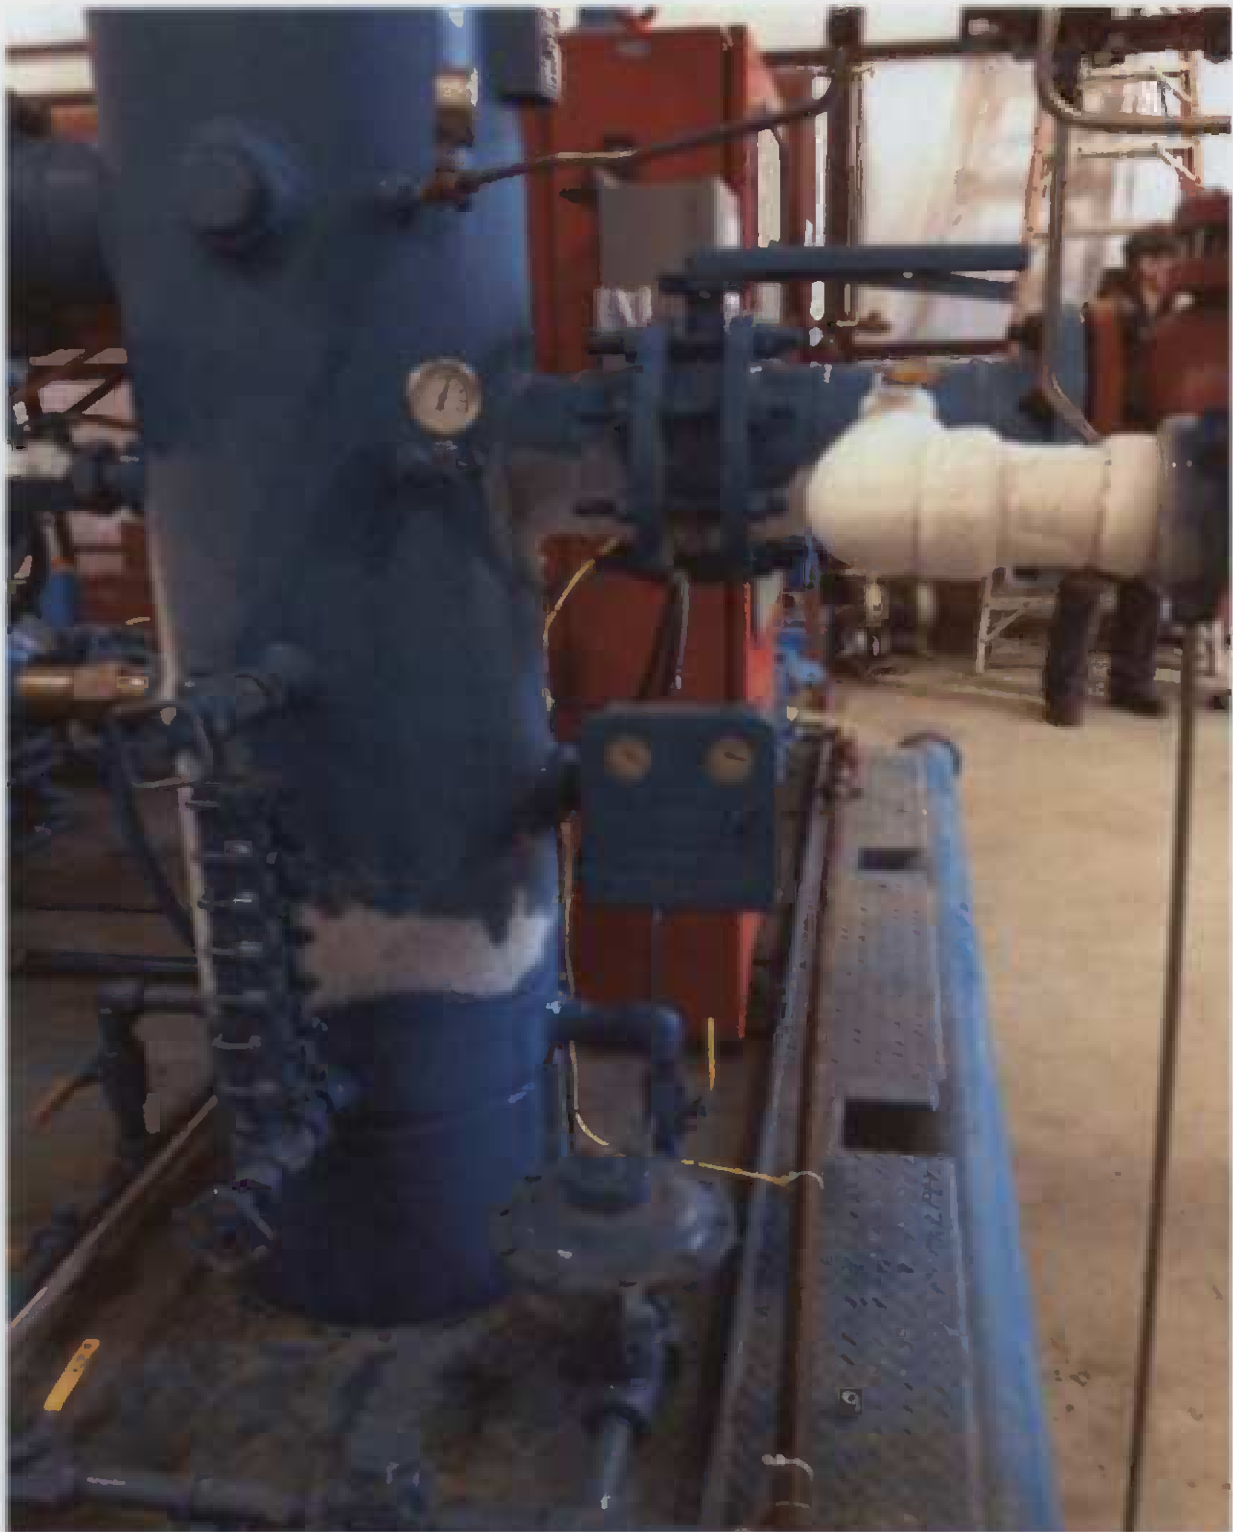
During our IR camera and PID survey, we observed a few small leaks at the compressor (photos 5 & 6 and videos MOV_0445 through 0459).

5) Component (box with two dials) on compressor that was observed to be leaking using the IR camera (video MOV_0456).

All leaking components at the compressor and from the thief hatches and pressure relief device were pointed out to Savoy representatives.

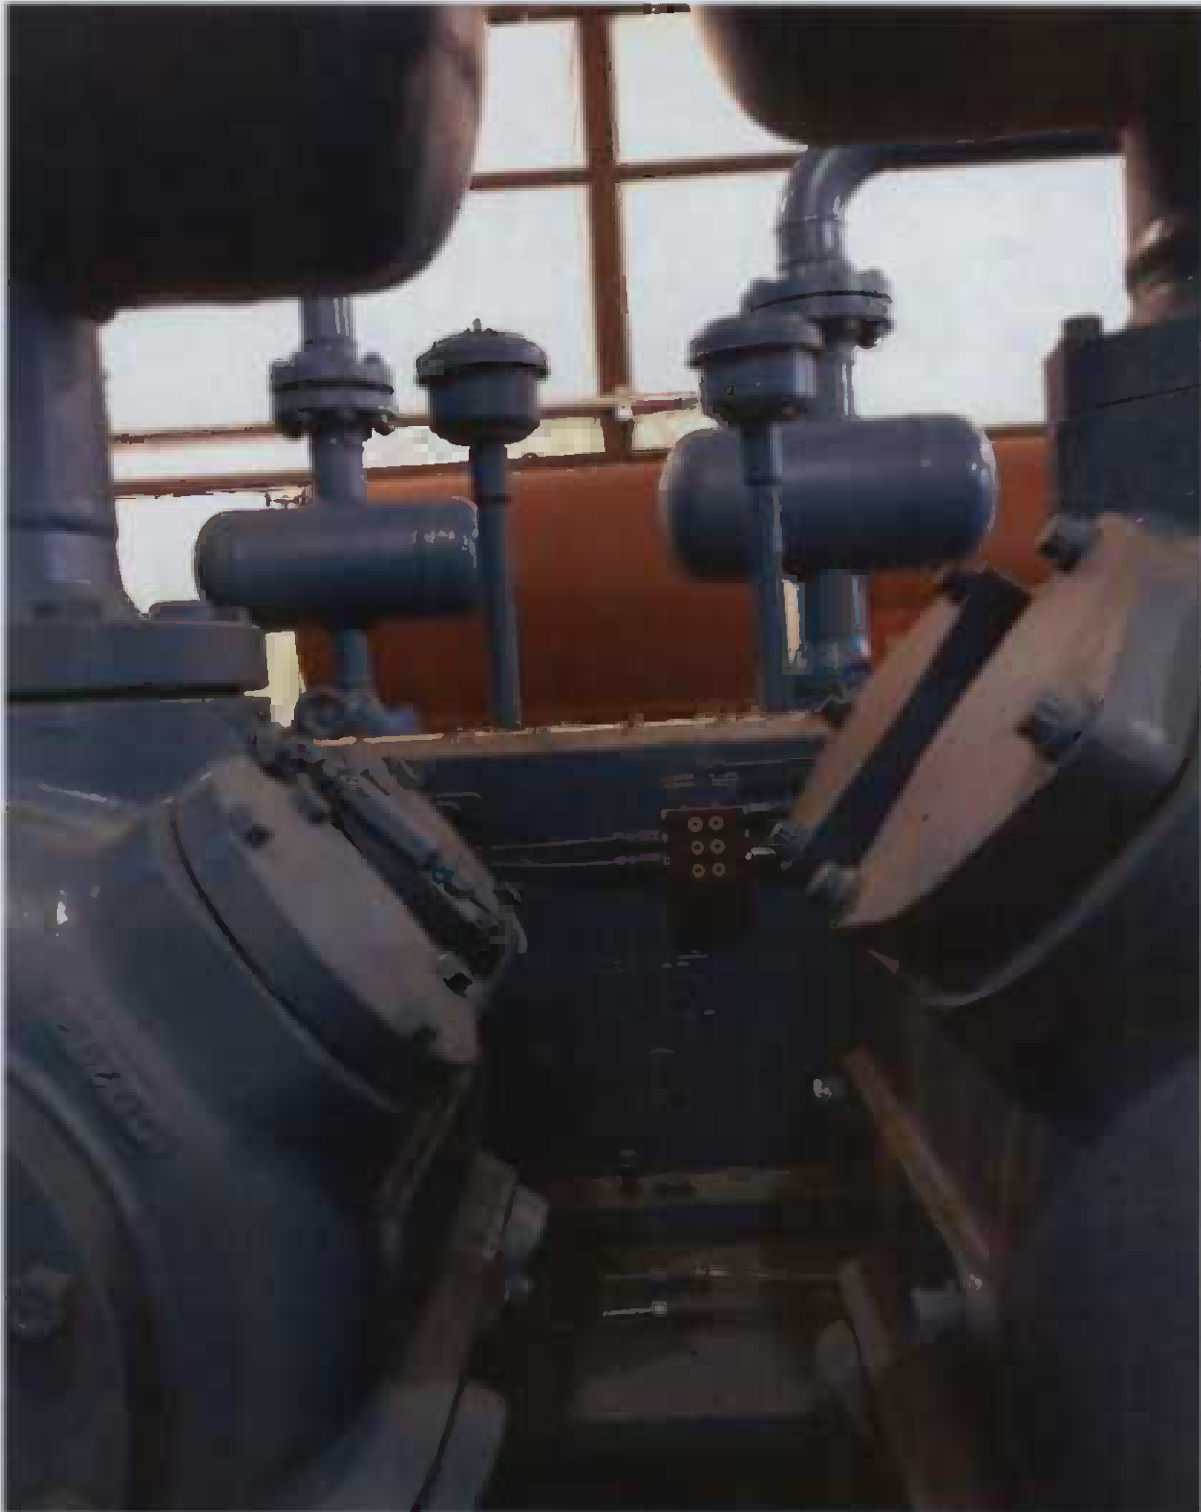
6) Component (the rightmost of two vertical pipes capped on top) on compressor that was observed to be leaking using the IR camera (MOV_0458).

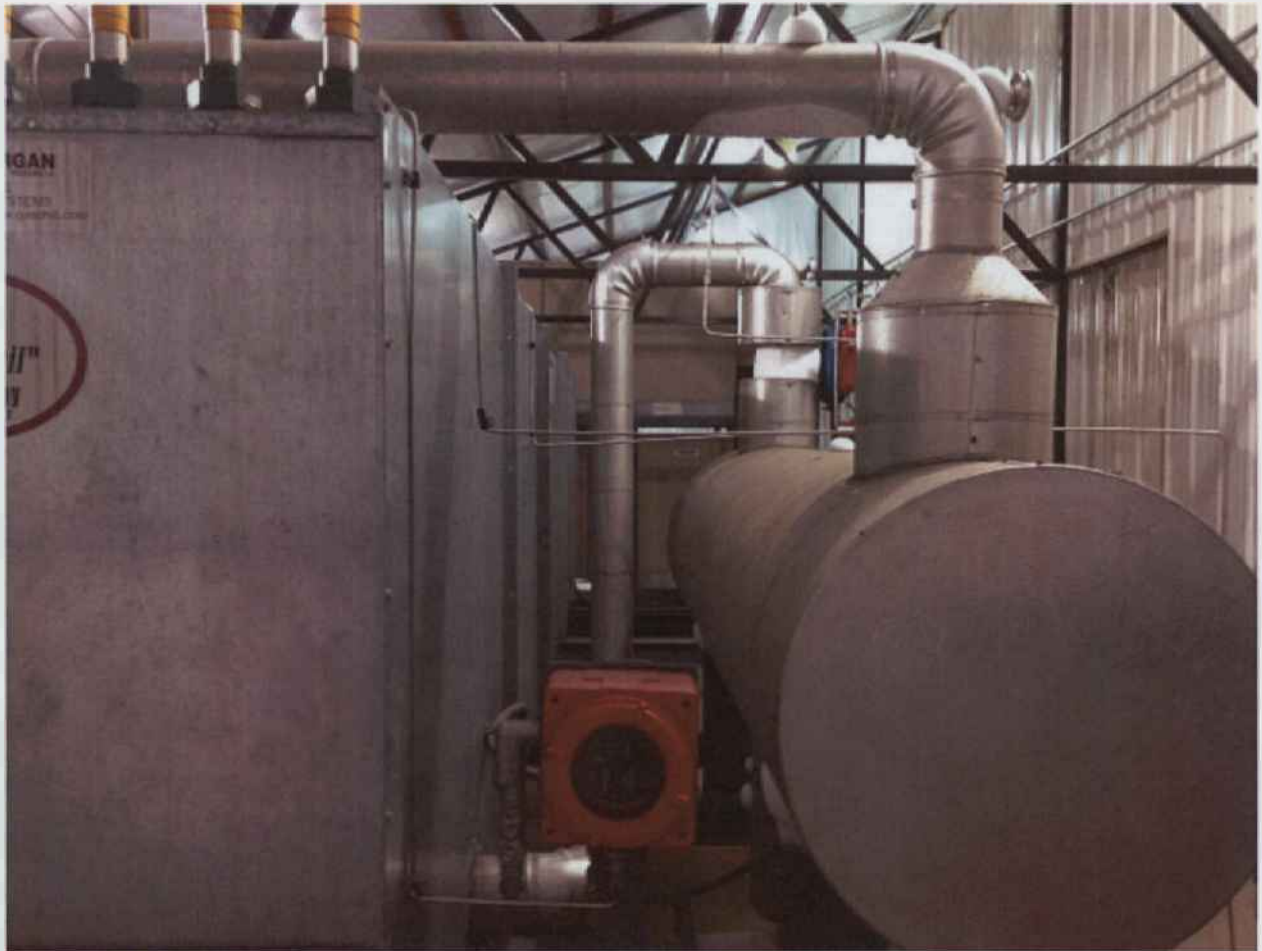
7) Chiller/refrigeration plant

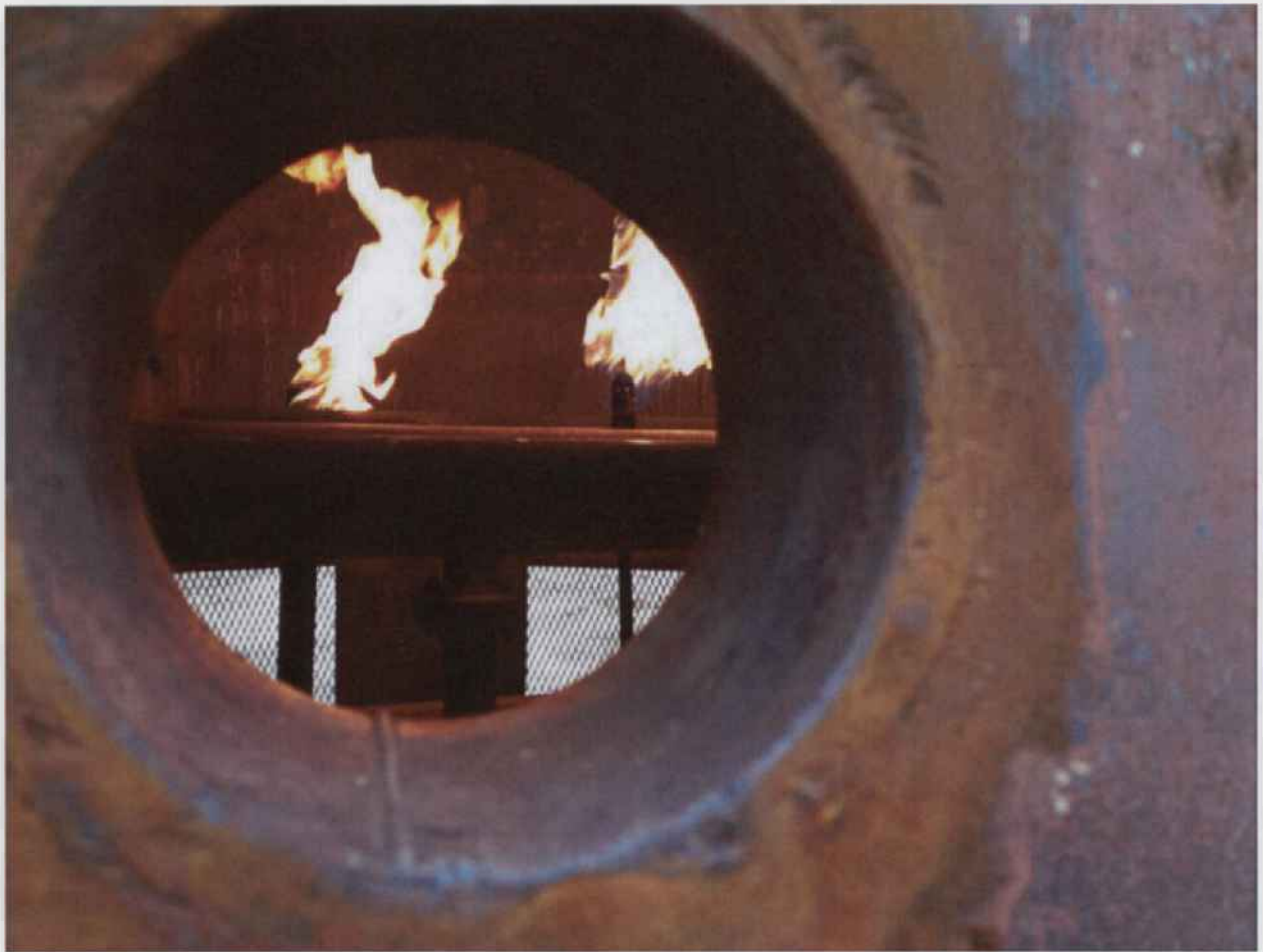
We conducted a preliminary walk-through and viewed the line heaters, heater treaters, glycol dehydrator, compressor, refrigeration plant, propane tank, oil and water tanks, and the flare. Observation of the flare showed a continuously lit pilot light and small bursts of flame when gases were vented to the flare (photo 9). We then received permission from Mr. Rokos to use our infrared (IR) camera and photo ionization detector (PID). Ms. Bellairs and I spent about 10 minutes in the car to power on the IR camera and allow it to cool down. During that time we also calibrated the PID using 10 ppm isobutylene calibration gas.

9) Flare flames through viewing portal in shroud. Continuous pilot flame is on right, gas line and flared gas is on left.

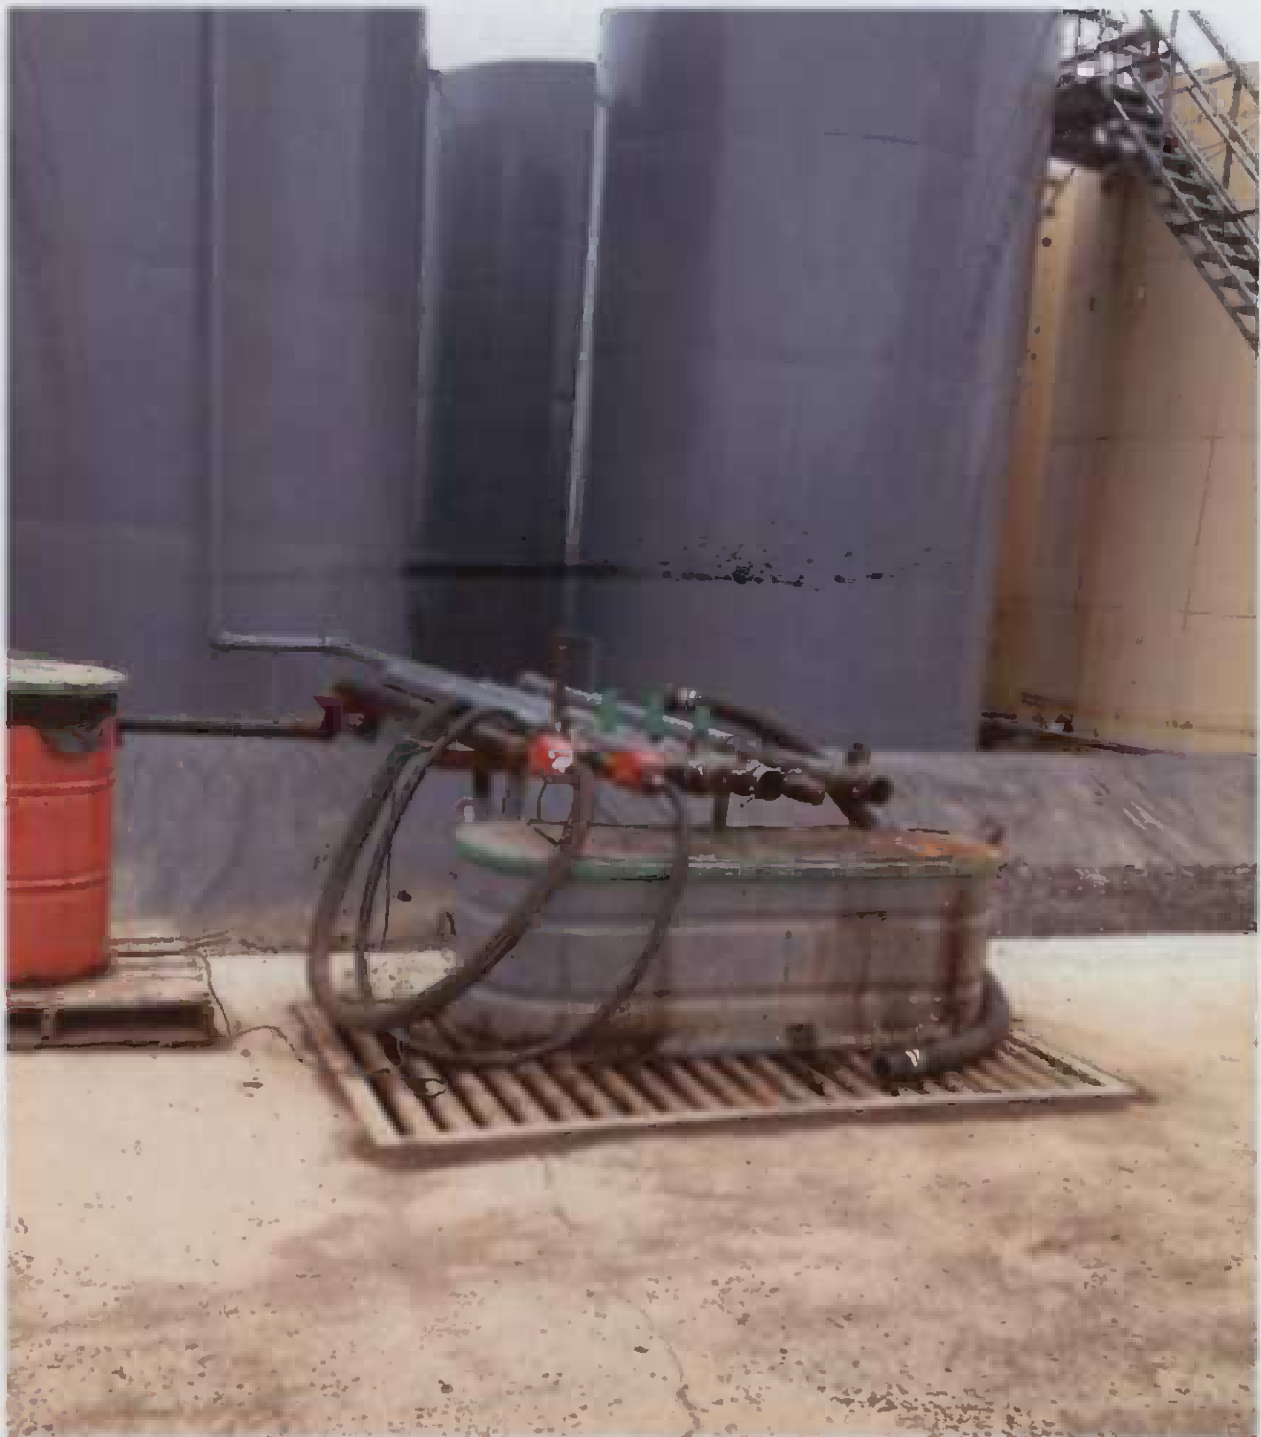
From the heater treater, the oil and water are piped to on-site storage tanks. At the Adrian 25 facility, there are four oil tanks and four water tanks, each with a capacity of 400 barrels. The tanks operate at ambient pressure and the oil is heated to about 100°F to allow it to be pumped easily. Mr. Rokos stated that the pressure rating of the tanks was 1 psi, and is typical for oil tanks in this application. The eight tanks are each equipped with spring-loaded thief hatches for checking liquid levels on about a daily basis. The tanks also share a common vapor recovery system which routes emissions from the tanks to a flare. The flare has a fuel line to maintain a pilot light and a large barrel shroud to protect the flame from wind and to reduce flame visibility (photo 8). Mr. Rokos stated that the pilot light is checked two or three times per day to ensure that it remained lit. Vapors from the tanks' headspace are piped to the flare at ambient pressure (no fan or pump is used to draw vapors from the tanks to the flare). Since the system uses a common collection line, vapors from each individual tank can flow to the headspace of any other tank. The vapor collection lines are equipped with two Enardo pressure relief valves. The tank system has a line for loading oil into trucks and a line that vents vapors during loading to the flare (photo 10) Mr. Rokos stated that the Adrian 25 facility is serviced by two to three oil trucks per day.

10) Oil loading with drain.

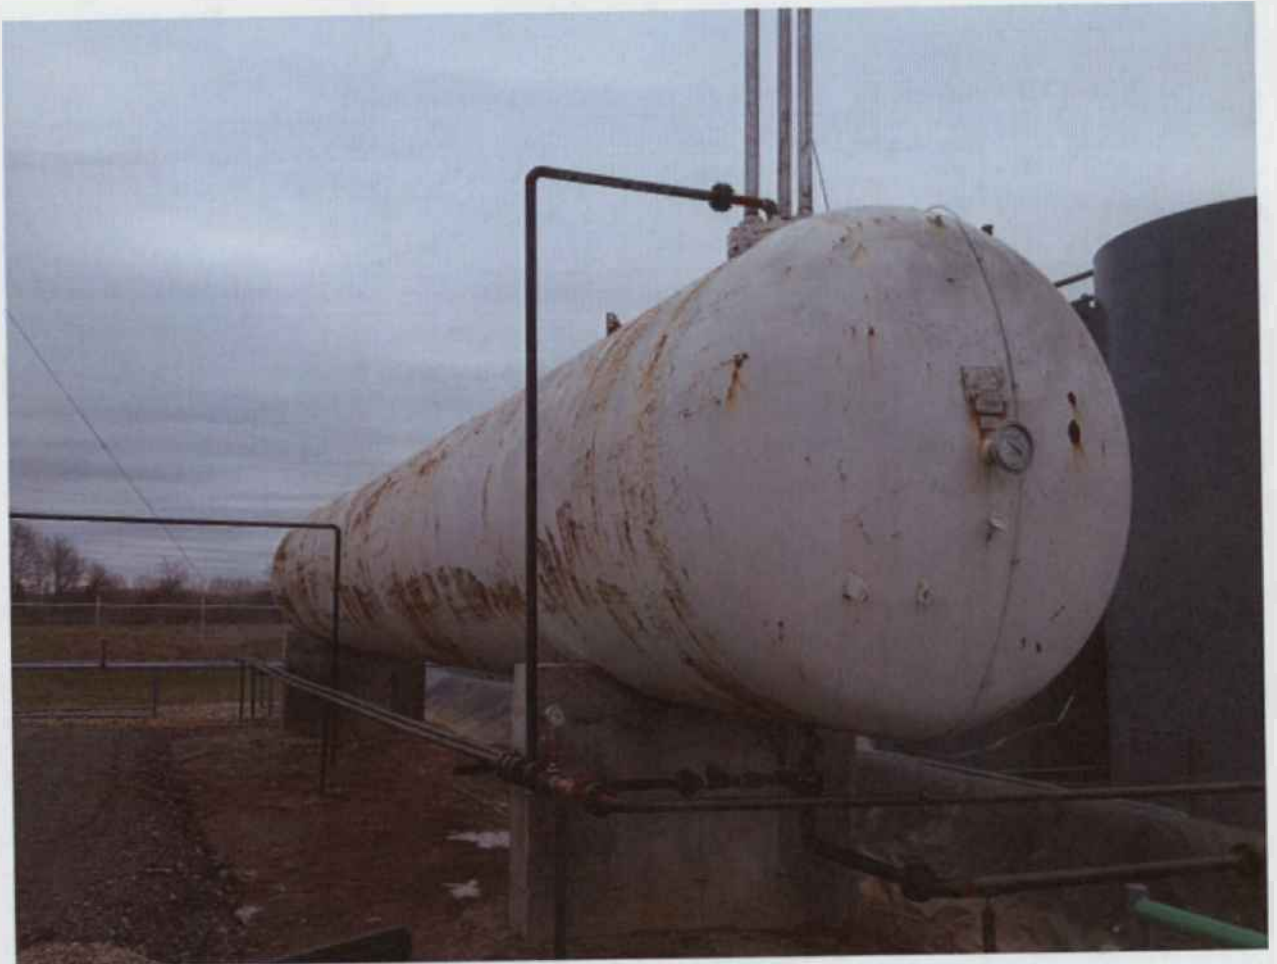
11) Propane tank.
